## **Cultural Resources Survey of the Prue Road and Detention Basin Project in Bexar County, Texas**

Prepared for  
**Adams Environmental, Inc.**

SWCA Cultural Resources Report No. 09-194

June 2009

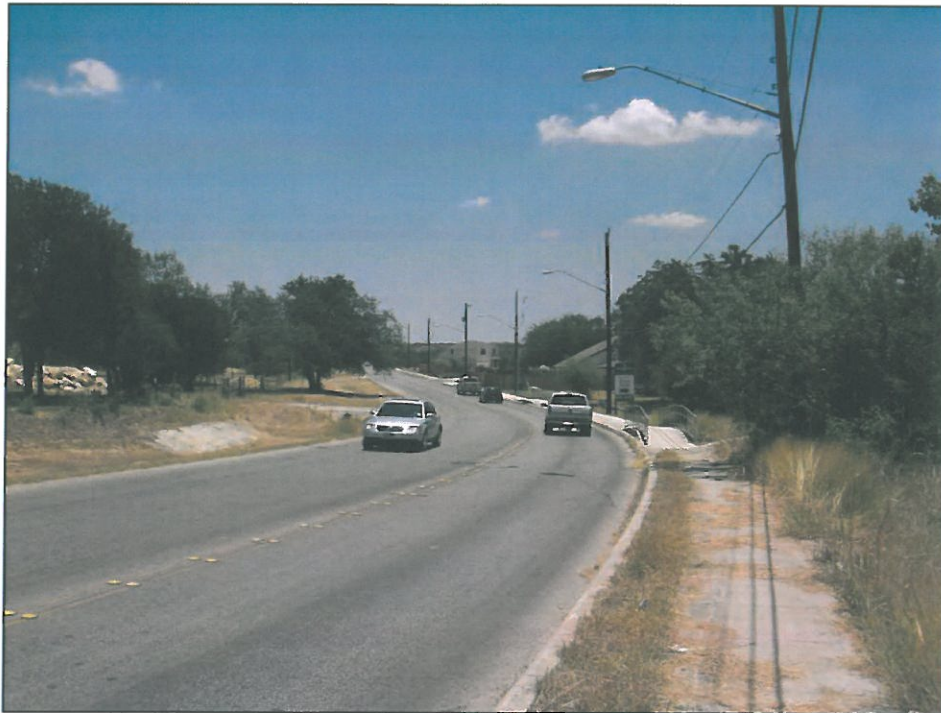
**Figure 2. Facing east, from the western terminus of APE, overview of Prue Road with residential development and above ground utilities.**

bances within APE include subdivision fence lines, drive-ways, side-walks, overhead and buried utilities (Figure 2). Overhead utilities consist of a transmission line along the southern right-of-way of the APE. Buried utilities within the APE consist of waterlines, sewage lines, telecommunication cables, and television cables (Figure 3). Initially surveyed in 2001, the Leon Creek Greenway Hike and Bike Trail is located on the eastern bank of the Leon creek intersecting the APE. The proposed detention basin, located in an open field west of Leon Creek contains dirt and gravel mounds within most of the eastern portion and a two track road along its northern boundary (Figure 4).

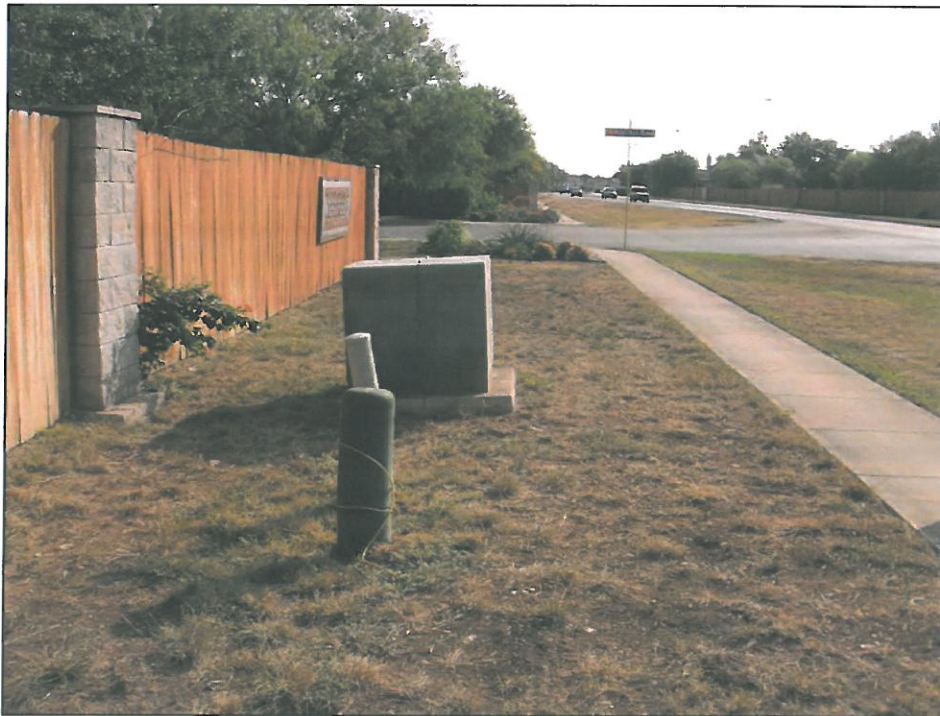
**Figure 3. Facing east, east of Leon Creek along northern right-of-way, overview of buried utilities.**

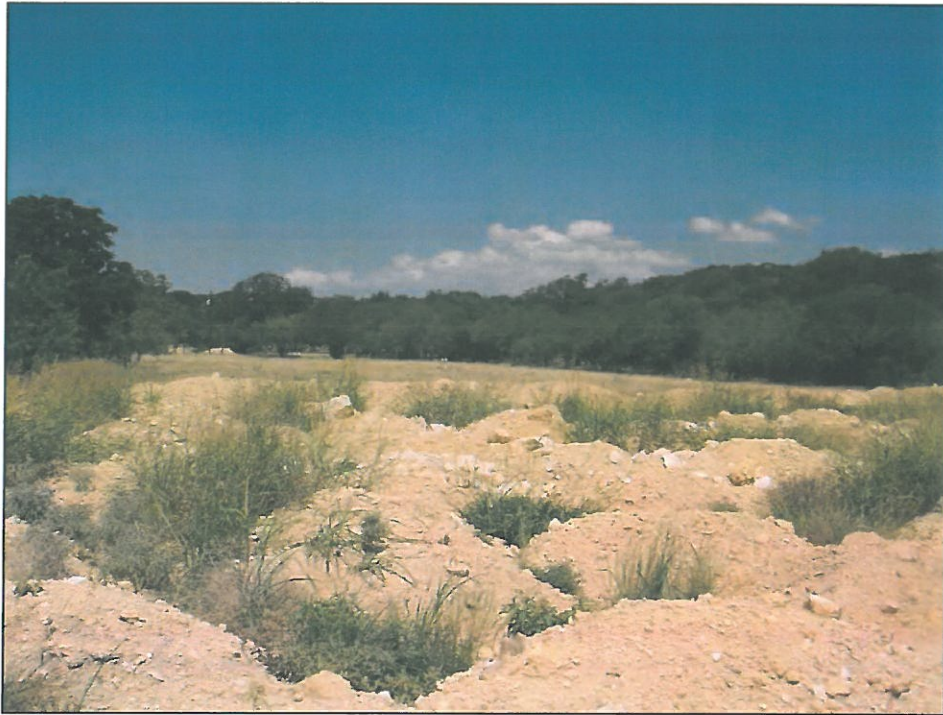
**Figure 4. Facing west from southeast corner of detention basin area, overview of dirt piles.**

portion of the detention basin area and consist of chert cobbles, limestone gravels, and fossilized shell (see Figure 4). Shovel tests determined the dirt was brought in from outside the project area.

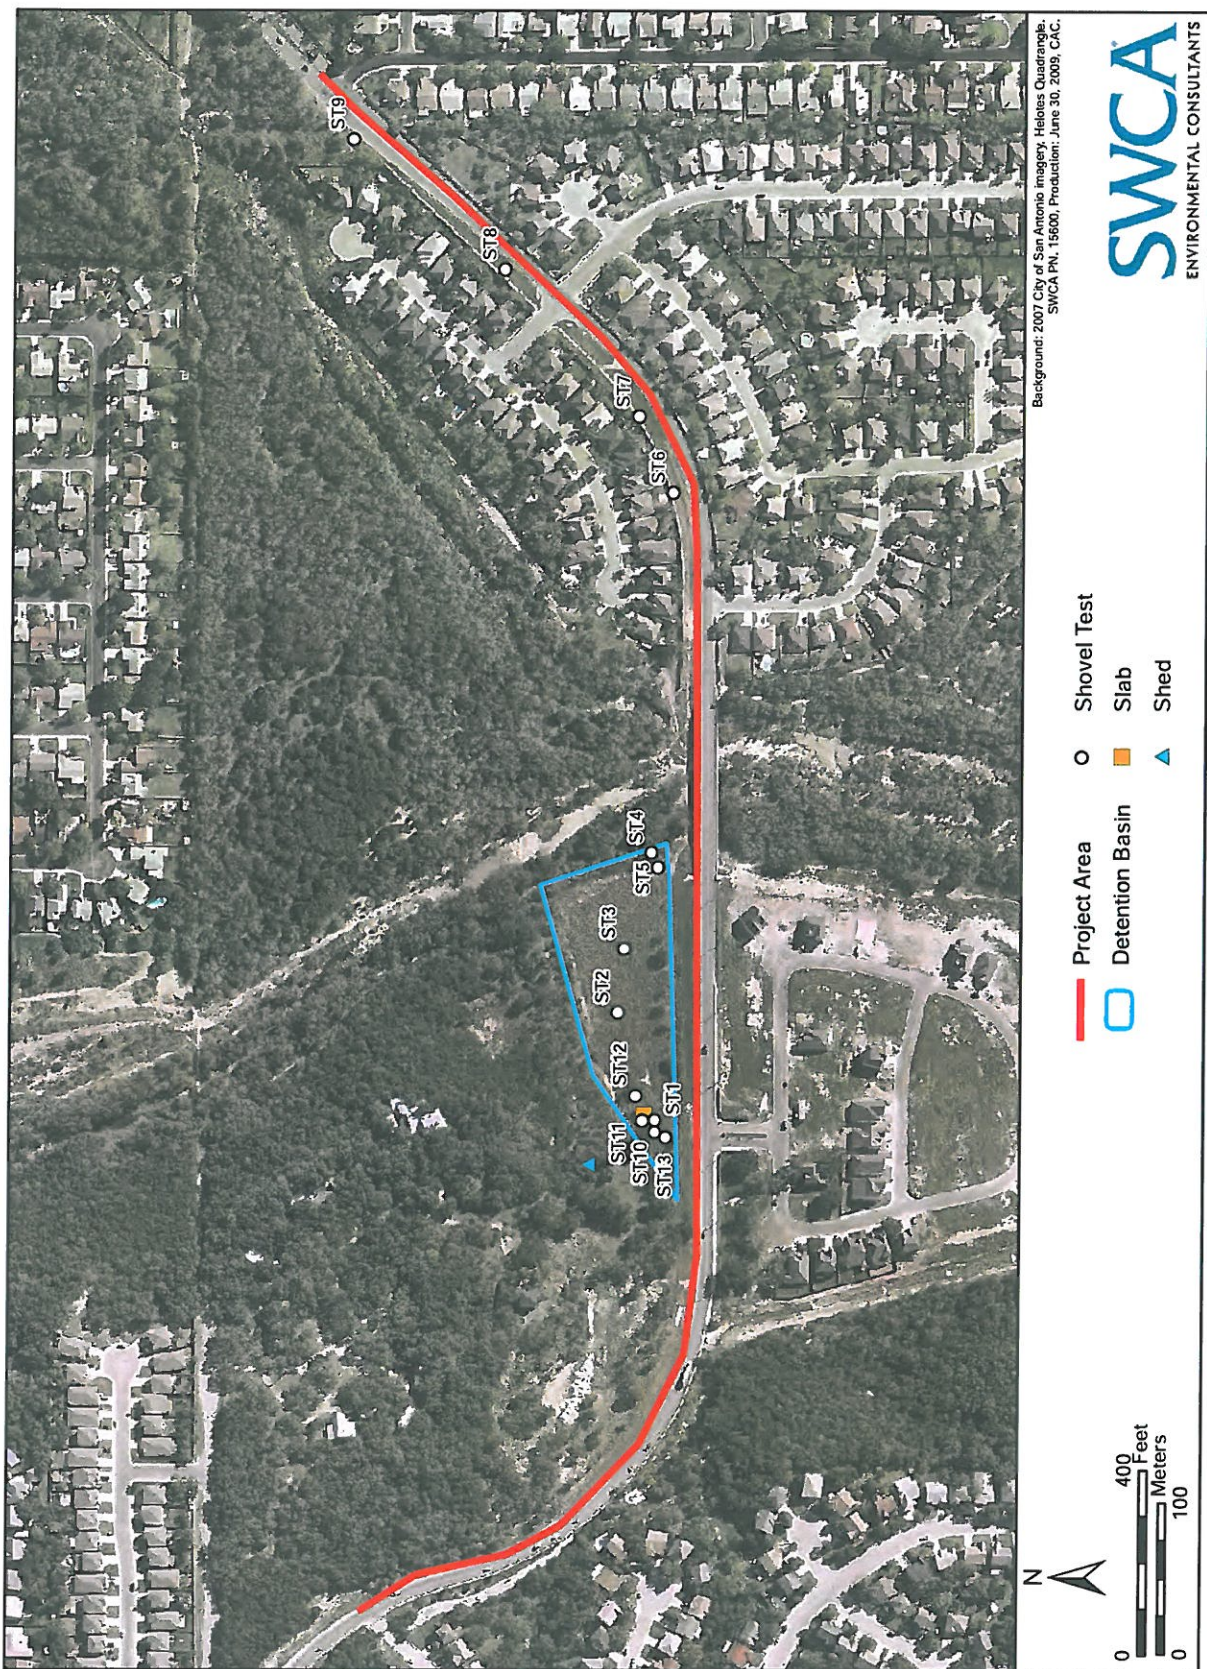
Figure 5. Overview of project area with shovel test locations.

Along Prue Road, shovel tests were limited to the northern right-of-way of the APE in the eastern portion of the project area where soils were present and shovel testing was possible (Figure 5, Table 1). The western portion consists of a steep upland terrace with exposed bedrock along the northern right-of-way. The four shovel tests along the APE encountered shallow gravelly clay loam and all were negative for cultural resources. The various disturbances related to residential development within the APE have eliminated the potential for intact cultural deposits. At the time of survey, vegetation was limited to areas between the sidewalk and road along the northern right-of-way; some areas with 100 percent ground surface visibility revealing gravelly clay loam.

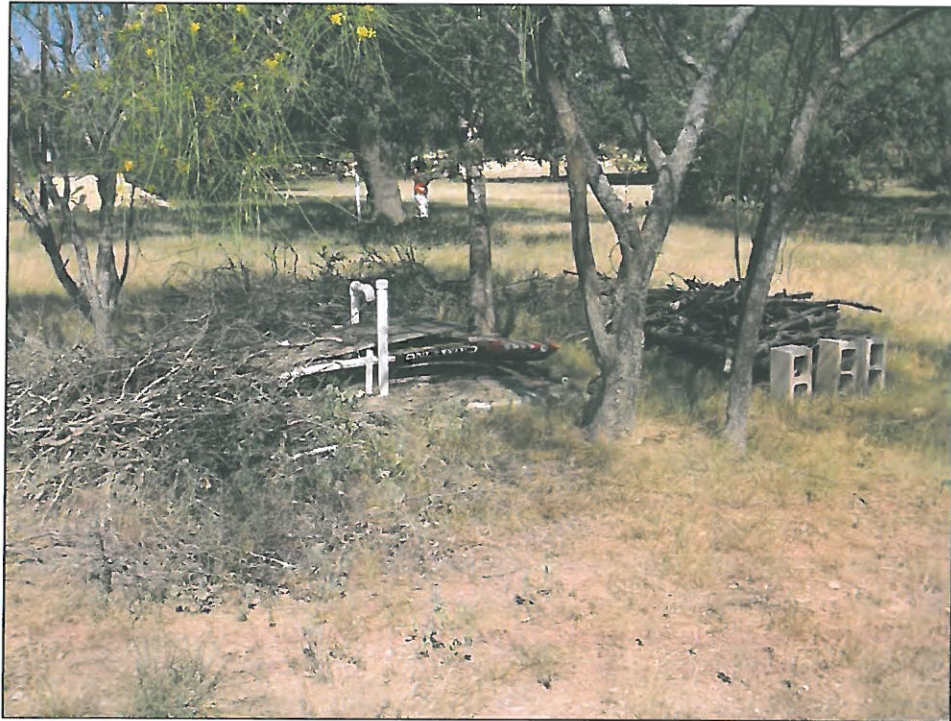
**Figure 7. Facing west, overview of concrete slab with PVC piping and debris.**

The remaining shovel tests were excavated in the western portion of the proposed detention basin and consisted of gravelly clay loam terminating at impenetrable compact clay. Shovel tests were concentrated in this area due to a concrete slab feature observed within the project area as well as the potential for deeply buried deposits. The slab covered with debris contained PVC piping and was approximately 1.5-m-x-1.5-m in size (Figure 7). An old abandoned utility pole and garage shed located outside of the project area may be related to the feature. The garage shed is located approximately 40 m northwest of the project area with an associated cistern and old tractor (Figure 8 and Figure 9). Overall, the garage shed and concrete slab appear to be modern with no historic significance. Although site 41BX1632 is located adjacent to the project area, it is unlikely that the features detailed above are related. According to the UTM coordinates recorded on the site form, 41BX1632 is located approximately 100 m northwest of the project area on a hilltop. No additional historic features or artifacts were encountered within the detention basin area.

No evidence of previously recorded site 41BX1632 was observed in the APE. According to maps, the site is located roughly 100 m from the APE. No visible evidence of the site could be seen from the APE and it appears this structure has been demolished since its documentation. The concrete feature located at the western portion of the detention basin was determined to be of modern date and no additional cultural materials were observed within the APE. Accordingly, no significant cultural resources will be affected by any construction activities within the project area. SWCA recommends no further archaeological investigations within the project area.

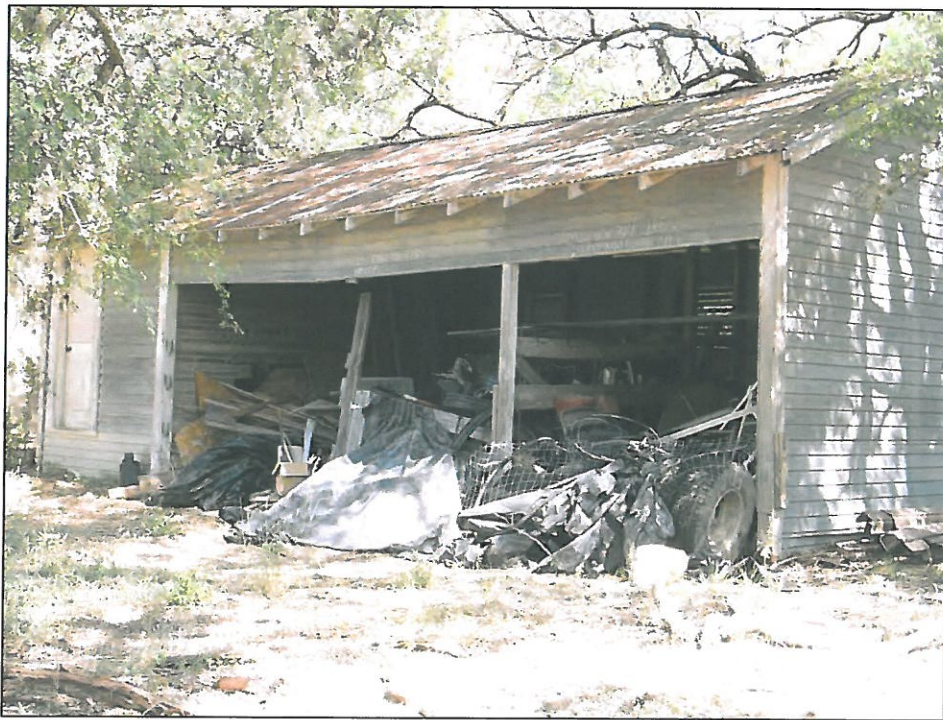
**Figure 8. Facing west, shed located northwest of the project area.**

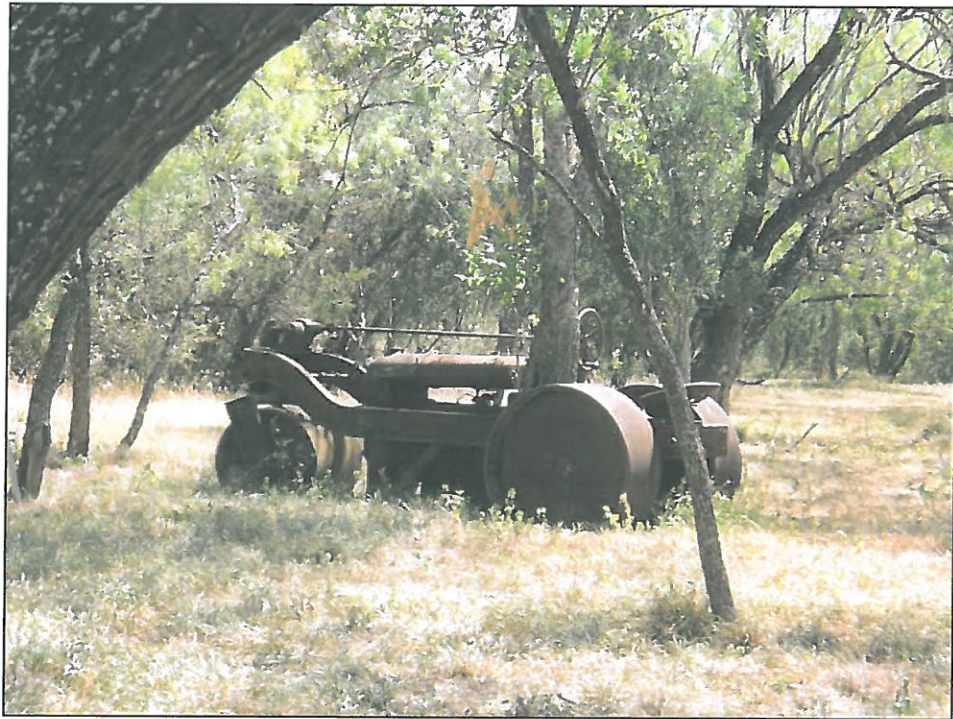
**Figure 9. Facing east from shed, view of old tractor.**

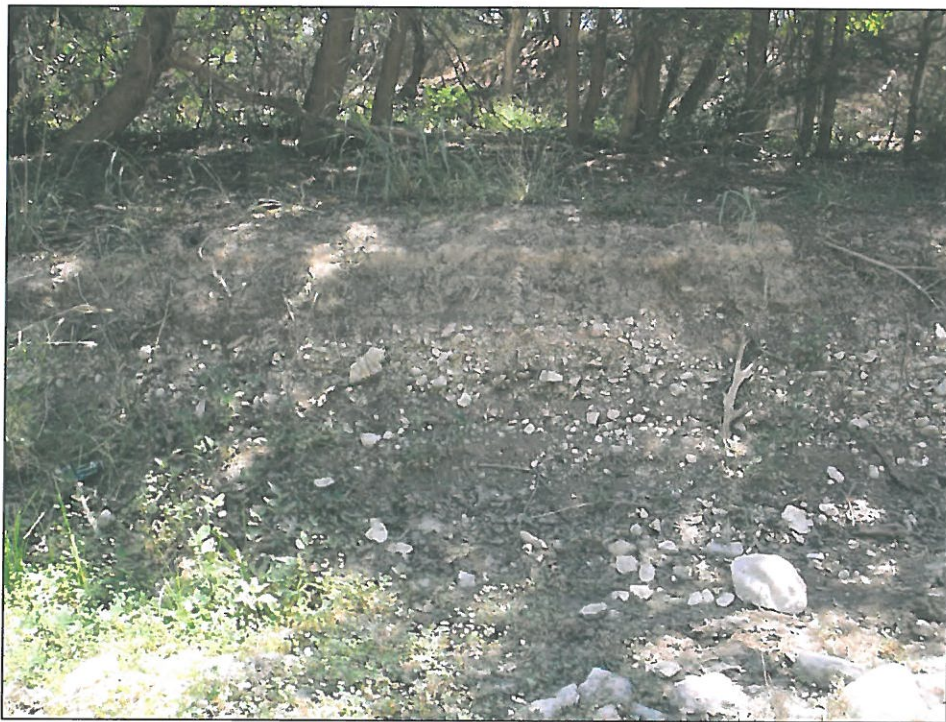
**Figure 10. Facing west, from creek bed of Leon Creek, western profile of creek with dirt piles in background through trees.**

Although backhoe trenching was initially proposed for this area, the surface and subsurface investigations revealed no deep sediments in the APE that would necessitate such mechanical work. Shovel tests revealed compact gravelly clay loam throughout most of the detention basin area and evidence of fossil material (ST 11, see Table 1). A review of the profiles along Leon Creek determined that soils are shallow over gravels (Figure 10). Shovel tests along the western terrace of Leon Creek (ST 4 and 5, see Table 1) revealed 10 cmbs of gravelly silt over dense gravels. The terraces along

Leon Creek did not contain fine alluvial sediments that typically contain deeply buried deposits. In addition, the previously conducted surveys along Leon Creek for the SAPRD in 1998 and 2001 did not encounter any cultural resource sites. The setting and soils of the project area suggests the area is rarely flooded and prone to water erosion, minimizing alluvial deposition. Overall, the potential for deeply buried or intact buried deposits is very low.
